# Case Study

Project: **Stockton Beach S.L.S.C**  
 Location: **Newcastle, NSW, Australia**  
 Client: **City of Newcastle**  
 Contractor: **City of Newcastle**  
 Consultant: **WBM Oceanics**  
 Date: **1996 - 2007**

UPDATE  
2007

## ELCOROCK®

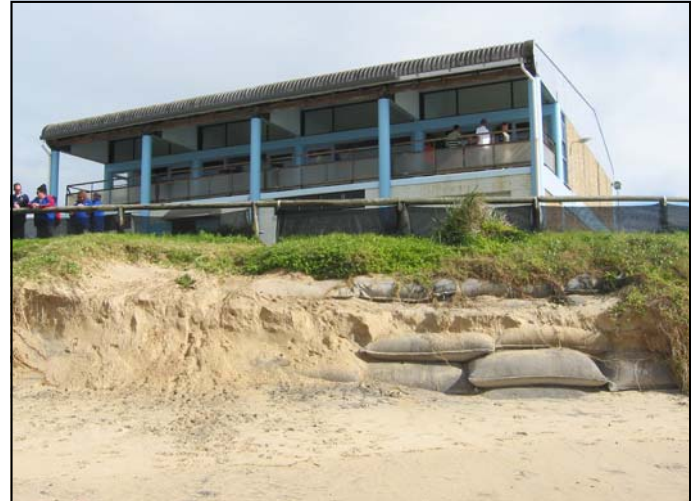
*ELCOROCK® exposed after severe sea swells*

Once again, the ELCOROCK® sand containers proved effective in preventing any damage to the Stockton Surf Club. Despite sand being eroded from the beach and exposing the sand containers, the structure, being flexible, remained intact and in fact there were no visible signs of displacement. Sections of beach on either side of the Club have been subjected to ongoing erosion by wind and wave action since 1996 more than eleven years ago.

The original structure consisted of 2 tonne ELCOROCK® sand containers laid in a stretcher bond formation to ensure maximum interlock at 1.5H:1V slope. A self healing “Dutch Toe” was incorporated into the design to prevent scouring during storm events. In addition heavy duty UV stabilised non woven staple fibre needle-punched ELCOMAX® 900R was used between the sand and sand containers.

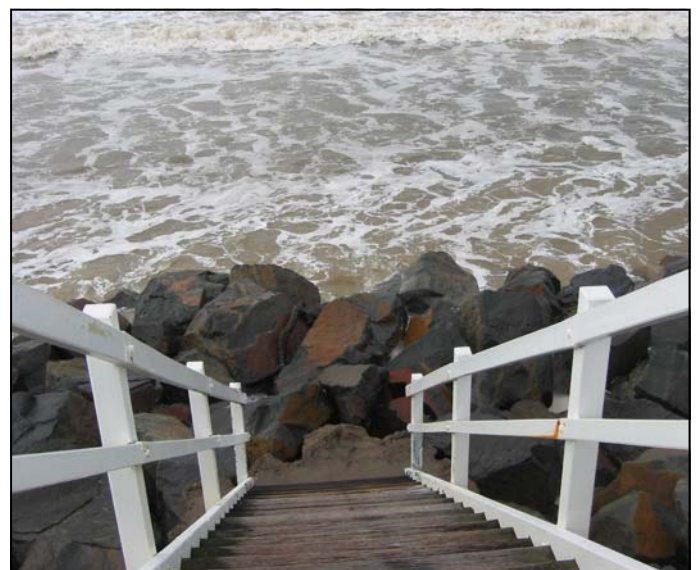
*Displaced rock armour protection*

In contrast to the sand containers, rock armour protection was constructed approximately five hundred metres north of the Surf Club by Council. However, as a result of the latest wave action and loss of sand, rock has been displaced and rendered the beach inaccessible to the public. In addition, to being unsightly, the cost to remediate the rock armour is an expensive and time consuming operation.
