Case Study

Project: **Stockton Beach S.L.S.C**
 Location: **Newcastle, NSW, Australia**
 Client: **City of Newcastle**
 Contractor: **City of Newcastle**
 Consultant: **WBM Oceanics**
 Date: **October 1996**

ELCOROCK®

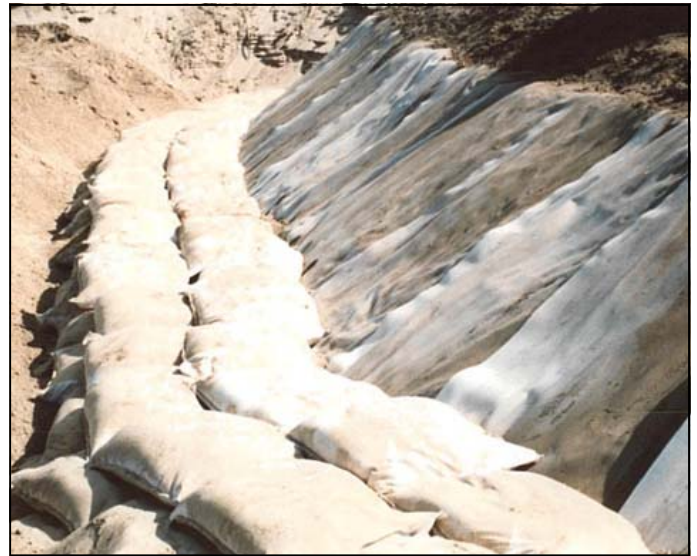
During construction – ELCOMAX® install under ELCOROCK®

The toe of the wall was located 0.5m below the low tide level and a "Dutch Toe" scour protection detail was included. The wall was constructed using a double layer of 2t ELCOROCK® containers at a slope of 1:1.5.

ELCO Solutions Pty Ltd supplied the filling frames and sewing machines to help with the construction. The containers were placed using a rock grab attached to a 24t excavator. Approximately 15 bags were placed per hour.

A total of 460, 2152RX8 ELCOROCK® Sand Containers together with 900m² ELCOMAX® 1200R was installed.

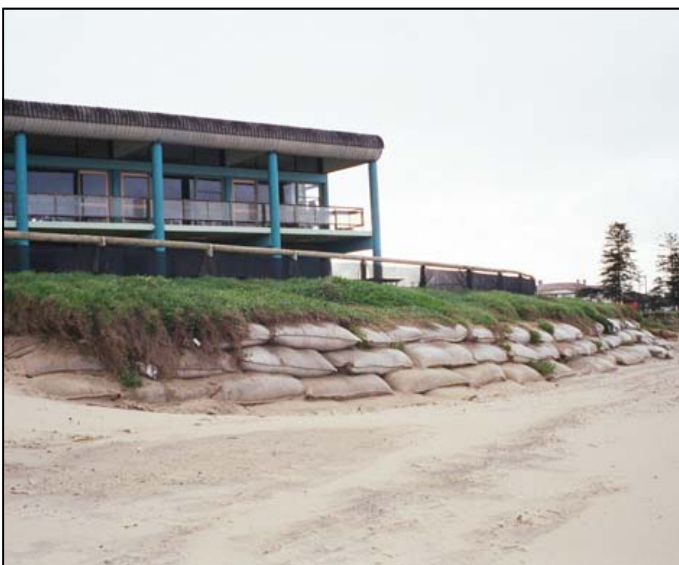
Photo taken July 2000

Natural vegetation was planted above the wall and this has now begun to grow over the front face of the wall. The soft user-friendly character of the ELCOROCK® containers, combined with the environmentally friendly appearance, make this product the ideal solution for popular beaches.
