Case Study

Project: **Sonaisali Groynes**
 Location: **Sonaisali, Fiji**
 Client: **Sonaisali Island Resort**
 Contractor: **Foreshore Constructions**
 Date: **April 1998**

ELCOROCK®

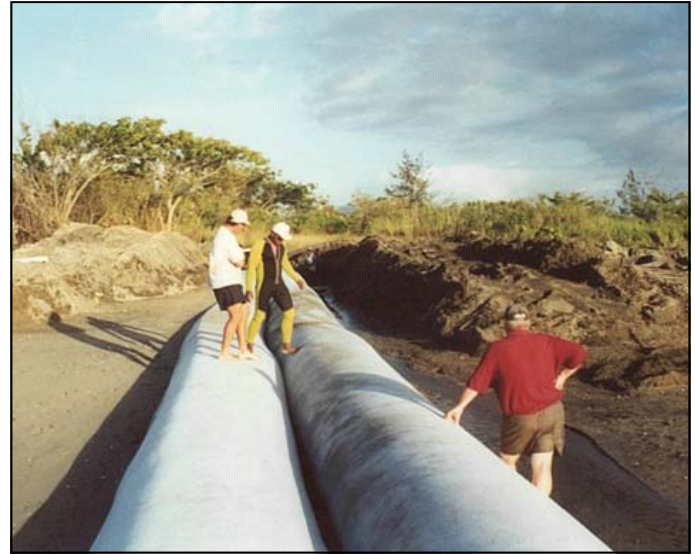
Installation of 2 base tubes

ELCOROCK® sand filled geotextile tubes were used to form the groynes. The groyne consisted of 3 1.2m Ø tubes placed in a pyramid shape i.e. two on the base and the third stacked on top.

The tubes were filled using a 150mm (6") pump and took approximately 2 ½ hours each to fill.

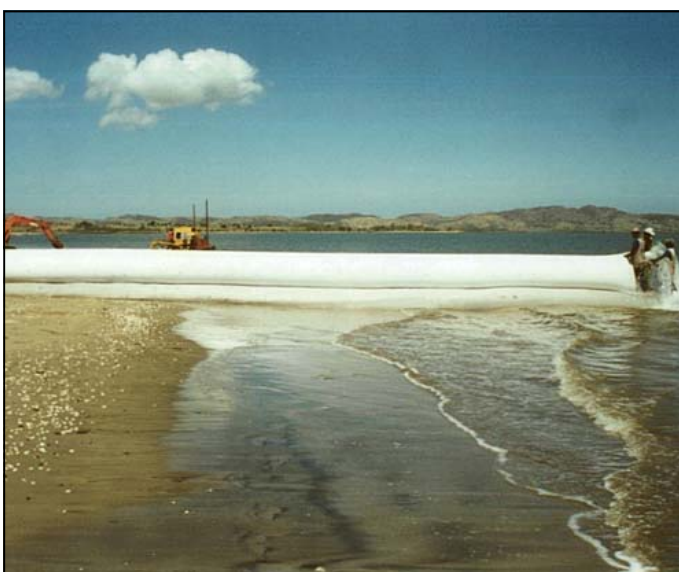
Significant beach widening

The project has resulted in significant widening of the beach frontage to the resort and withstood its first cyclone attack in January 2000.

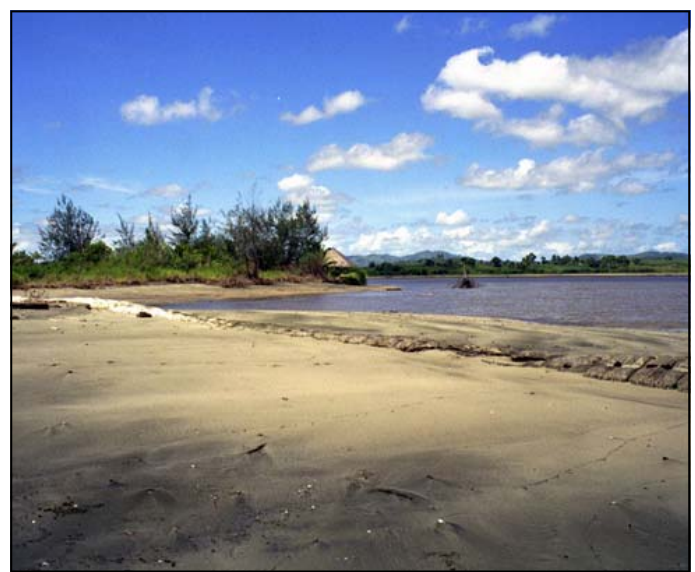
After the cyclone – March 2000
